Manhole Inspection Summary

Manhole # S37C__010MH

Insp Date: **2/13/09 10:16 AM**

Location Address: **842 HILLEN ST**

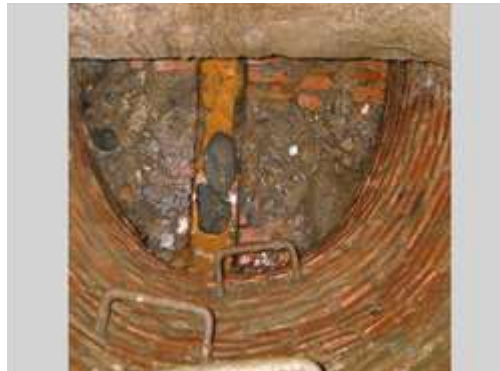
Top View

pipe connections @12 & @9 are obscured by MH shelf (note the rocks in the channel which were subsequently

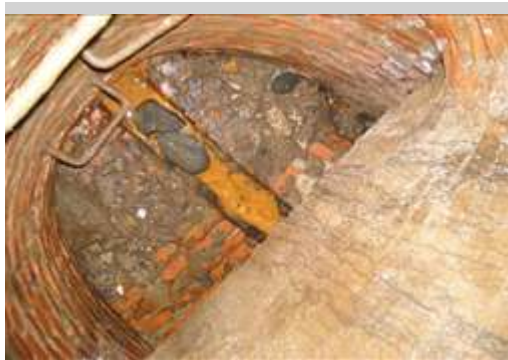
Miscellaneous

bench debris

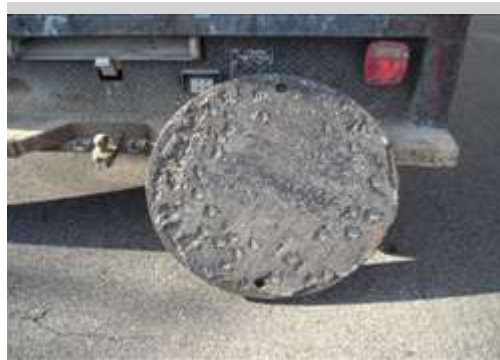
Miscellaneous

this 30" lid was removed from manhole. it is covered in asphalt, however it is still sturdy and was replaced.

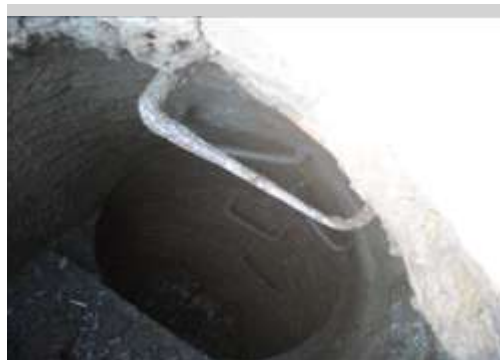
Defect 3

Count: **6** Missing: **0** ☒ **Corroded**

corroded steps

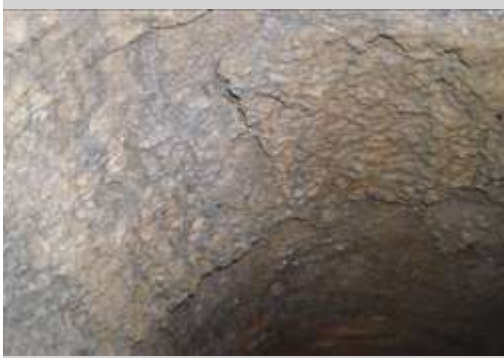
Defect 2

Condition: ☐ Sound ☐ Cracked ☒ **Leaks**

mud covered chimney wall indicates infiltration due to leaking frame

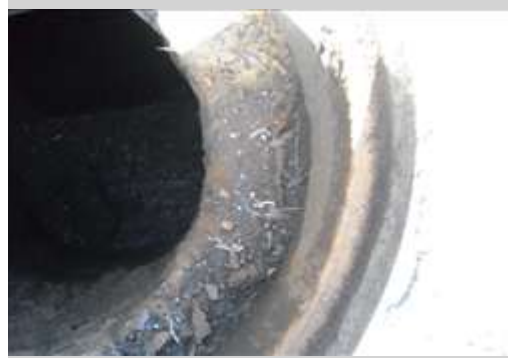
Defect 1

Offset: **6** (in.)

FRAME IS OFFSET BY 6"

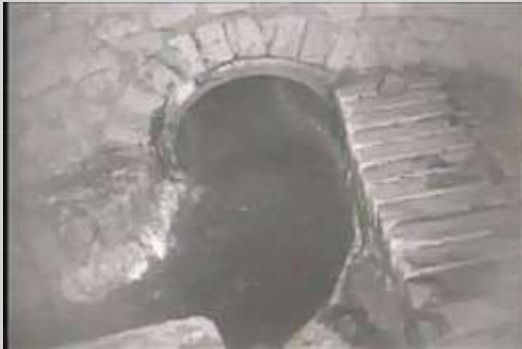
12 O'Clock Outflow

Infiltration: **None** Pipe Seal Cond: **Cracked**

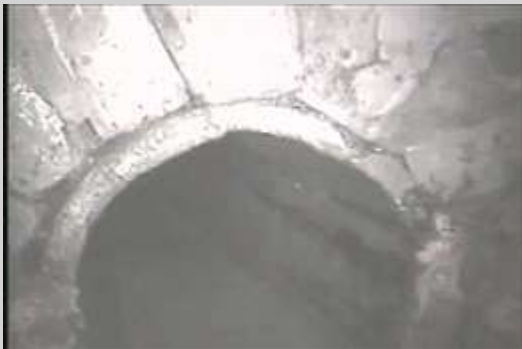
6 O'Clock Inflow

Deposits: ☐ None ☐ Mud ☒ Sludge ☒ Debris ☐ Grease

Silt Depth: 3 (in.) Deposits Extent: **Medium**

Infiltration: **None** Pipe Seal Cond: **Broken**
